Application of Geocell Track Substructure Support System to Correct Surface Degradation Problems Under High-Speed Passenger Railroad Operations

**Transportation Infrastructure
Geotechnology**

Transp. Infrastruct. Geotech. (2017)
4:106-125
DOI 10.1007/s40515-017-0042-x

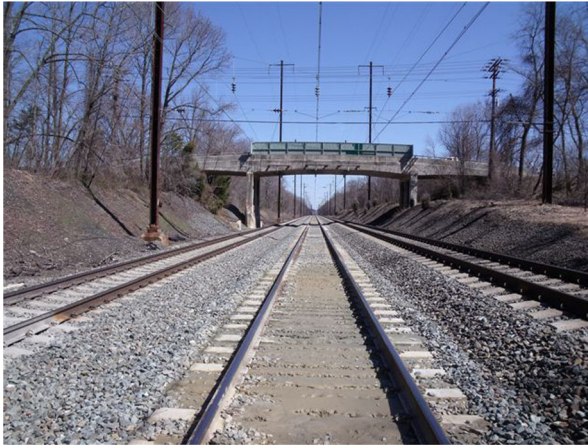
Fig. 1 Fouling and mud spots at Oakington Road, 2010

Ballast fouling and associated degradation of track geometry is a serious problem for railway systems in general and high-speed passenger rail systems in particular. This is the case for Amtrak's Northeast Corridor (NEC) where a long-term problem area existed near Oakington Road, Havre de Grace, Maryland, near MP 63.7 between Philadelphia and Washington DC. The original problem seems to have developed after undercutting of the middle track, track 3, was performed in the 1990s as part of a double stack clearance project. Over time, the ballast became fouled with clay, and after rain, the ballast would become muddy, as illustrated in Fig. 1.

The test site for this activity was on Amtrak's NEC Main Line-Mid-Atlantic Division, NEC AP-Line MP63.7, at Oakington Road, Havre de Grace, Maryland. As shown previously in Fig. 1, this site exhibits ballast fouling and develops significant mud spotting, particularly after rain. The original problem seems to have developed after undercutting of the middle track, track 3, was performed in the 1990s as part of a double stack clearance project. This undercutting appeared to have impinged upon an underlying clay layer beneath the track with the result that fouling and drainage problems developed in the area of Oakington Road MP 63.7.

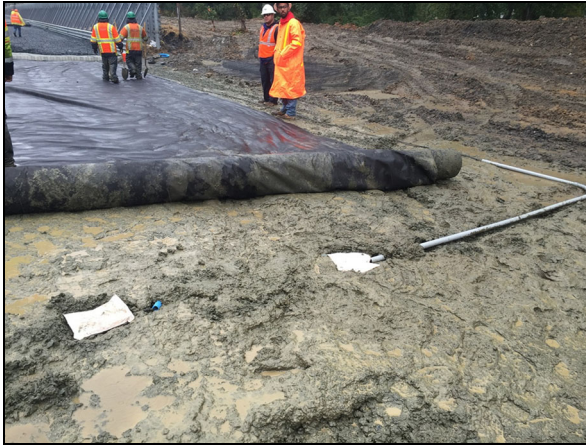
Fig. 6 Pressure cell installation in no geocell zone

load cells, such that the ballasts maintained uniform contact with the surface of load cell (see Fig. 6). Data acquisition was conducted using a portable high-speed dynamic strain recorder with a sampling rate of 5000 Hz (or interval of 200 μ s). Data logging was controlled through a portable computer.

The force transducers (pressure cells) were 8 in (20 cm) in diameter and 6.6 in (2.6 cm) thick and were manufactured by Tokyo Sokki Kenkyujo, Ltd. They had a capacity of 72 psi (500 kPa). During the installation, a biaxial geogrid was laid with sand above it, followed by the load cell. Then, sand bag was put over the surface of the

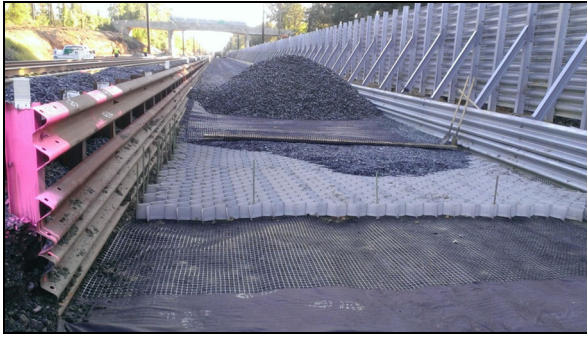
Fig. 7 Installation of the geocell material to build geocell reinforced track

Installation of geocell materials and load cells was conducted on September 28–30, 2015. Installation was performed by Amtrak forces supported by PRS Mediterranean Ltd. and the Harsco Rail/Columbia team. Amtrak personnel performed the actual section rehabilitation which included geocell installation. The process required taking the track out of service, removing the track superstructure, and then the actual ballast/subgrade rehabilitation and upgrade (with geocell material). **PRS Mediterranean Ltd., the manufacturer of the Neoweb geocell material, contributed the material and on-site advice to Amtrak both in the design of the installation and in the actual installation procedure.** Figure 7 illustrates the installation of the geocell material.

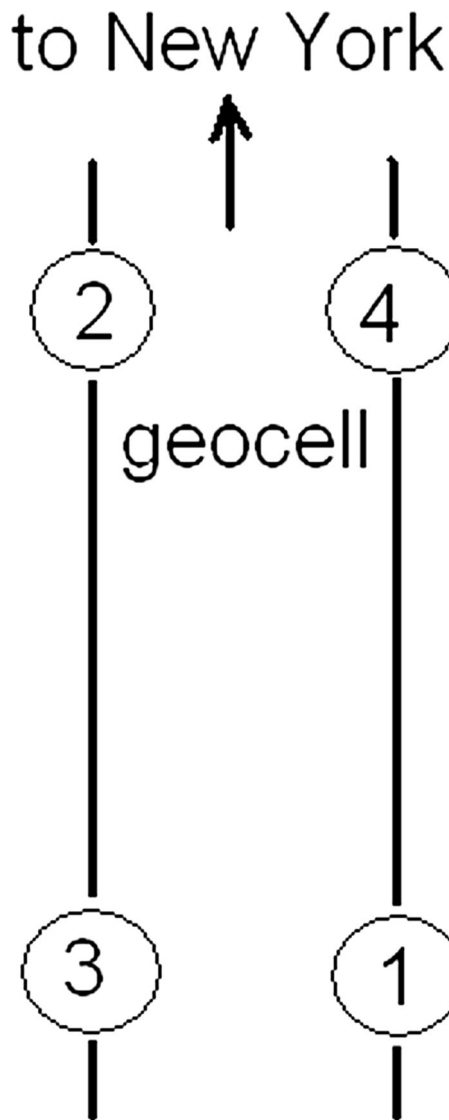
Subgrade pressure was monitored using four pressure cells (load cells), two each under each rail of the geocell and control sections, respectively. Figure 8 shows the load cell numeral designations. Load cells 2 and 4 are in the geocell zone, and cells 1 and 3 are in

Fig. 8 Load cell numbers and locations

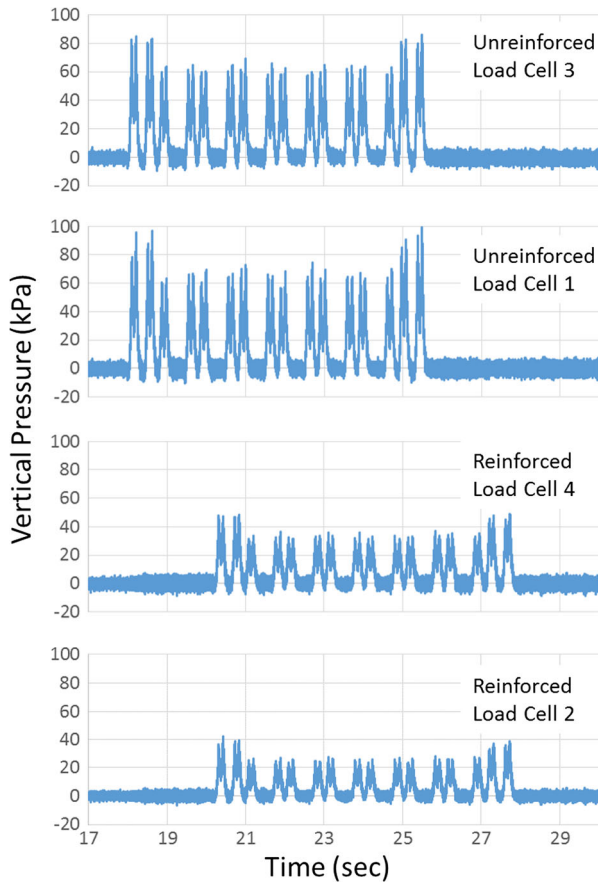
the outside control zone. The results for the passage of one train as recorded by the load cells are shown in Fig. 9. As can be seen from the figure, the locomotives (front and rear) generate higher loads than the passenger cars. The figure shows clearly that the pressure increments measured in the geocell-reinforced zone (cells 2 and 4) were less than those of the unreinforced zone (cells 1 and 4). The average values acting in the reinforced and unreinforced zones were 9.6 psi (66.5 kPa) and 4.6 psi (31.6 kPa), respectively. Thus, the geocell layer resulted in a redistribution and reduction of vertical pressure by nearly half.

Fig. 9 Load cells and measurements during train passage

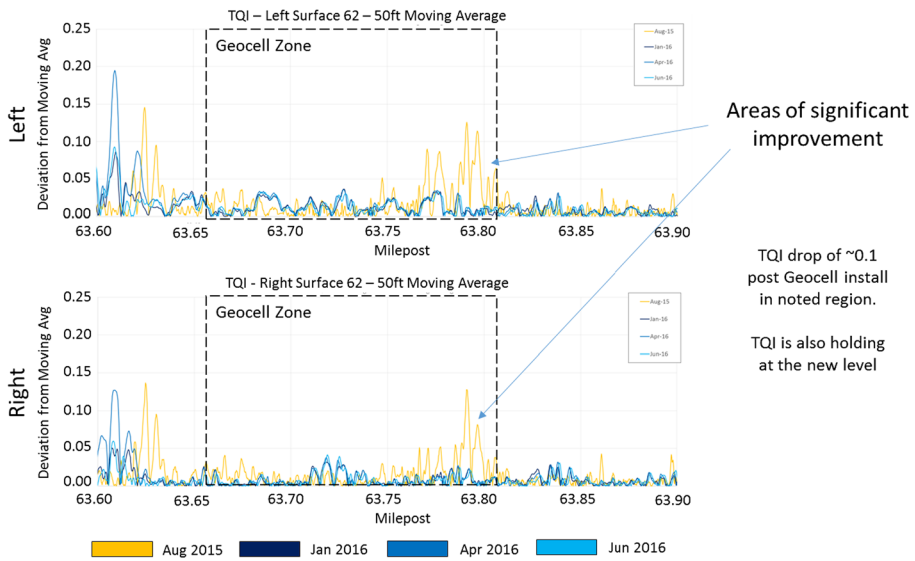
Figure 12 presents a 50-ft moving window calculation for combined left and right surface TQI for the same four time periods as shown previously in Fig. 11. Here too, the results match those presented in Fig. 11, with the non-geocell control zone north of the geocell zone showing high pre-reconstruction TQI values, corrected during reconstruction, and then reappearing and growing even larger by 7 months after reconstruction. By contrast, the geocell zone had large pre-reconstruction TQI values which were corrected during reconstruction and has a significantly reduced rate of regrowth, such that 7 months after reconstruction, the TQI values were about one third the pre-reconstruction values (as opposed to the northern control zone where they exceeded the August 2015 pre-reconstruction maximum values).

Fig. 12 TQI calculated with moving 50-ft window, left and right surface

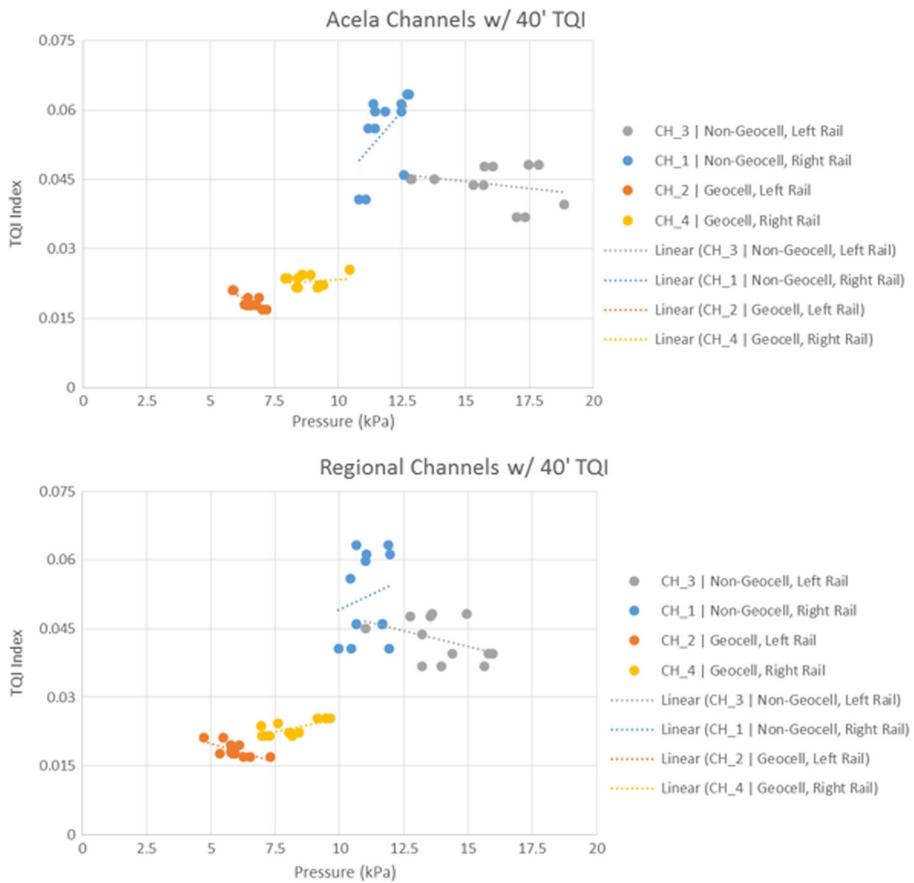
Figure 14 presents a “cross-mapping” of the TQI and pressure cell data for the Acela and Regional traffic, respectively. This cross-mapping is a correlation analysis between the two different sets of data. The results are quite interesting. For the geocell zone, under both the left and right rails, there is a well-defined relationship between lower pressure and lower TQI, corresponding to better track quality. This appears in the lower left quadrant of the graph in Fig. 14. For the non-geocell zone, under both the left and right rails, there is likewise a well-defined relationship between higher pressure and higher TQI, corresponding to poorer track quality. This appears in the upper right quadrant of the graph in Fig. 14. In each of the four cases, corresponding to each one of the pressure cells, there is a linear relationship between the actual pressure and TQI values. Furthermore, this relationship appears to exist for both the Acela and the

Regional traffic, though the actual loads, speeds, and pressure values are different. This data supports the previously shown results that the introduction of the geocell material improved track support, reduced bearing pressures on the subgrade, and provided improved track geometry performance over time.

Fig. 14 Cross-mapping of pressure and TQI data
