LIFE CYCLE BENEFITS OF SUBGRADE REINFORCEMENT USING GEOCELL ON A HIGHSPEED RAILWAY – A CASE STUDY

ABSTRACT

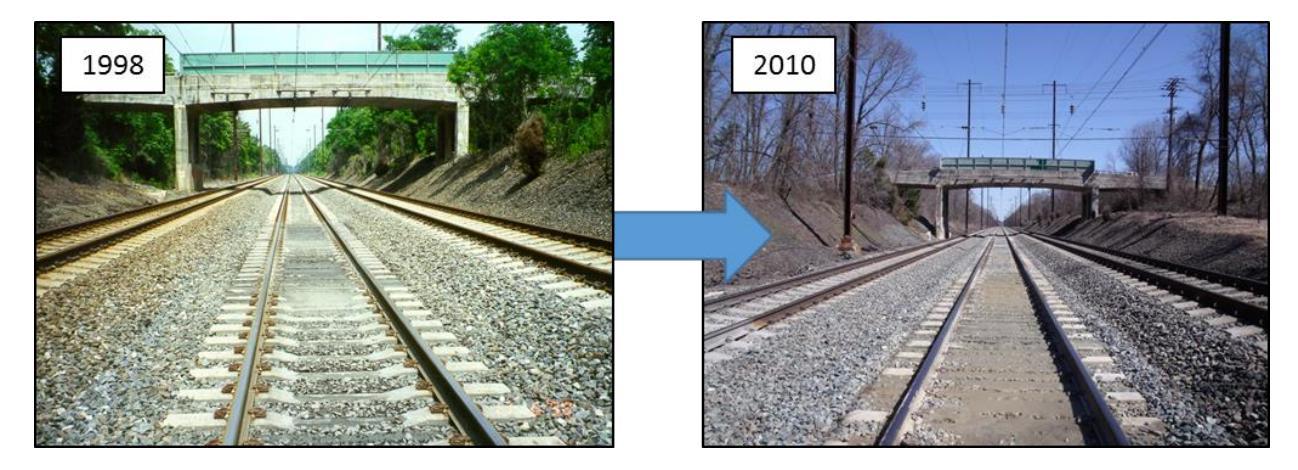
FIGURE 1: CHOSEN REBUILD SITE

A section of high speed rail had been experiencing ballast fouling and associated frequent maintenance due to rapid track geometry degradation. The root cause of this ballast fouling was traced back to undercutting conducted in the 1990s on the central of three adjacent tracks. The undercutting disturbed the underlying clay layer which caused the clay to migrate both into the track's ballast layer as well as into the ballast of the two adjacent tracks under saturated conditions with train traffic. Frequent surfacing was required to maintain track geometry in this area. Figure 1 illustrates the track roadbed degradation over time at the site.

The rebuild site (Figure 1) had been experiencing ballast fouling and development of mudspots (especially after periods of rain) ever since an undercutting procedure was conducted in the 1990s. This had led to a high rate of track geometry degradation and corresponding frequent maintenance. The site in question is FRA Class 7 track (8) and sees traffic from both high speed trains (125 mph) and higher speed regional trains (110 mph); some modest freight traffic is also seen on this segment of track. Due to its Class 7 rating, track geometry tolerances are very tight and in the event of excessive degradation, slow orders can be issued bringing the track class down to class 6 or class 5 depending upon the severity.

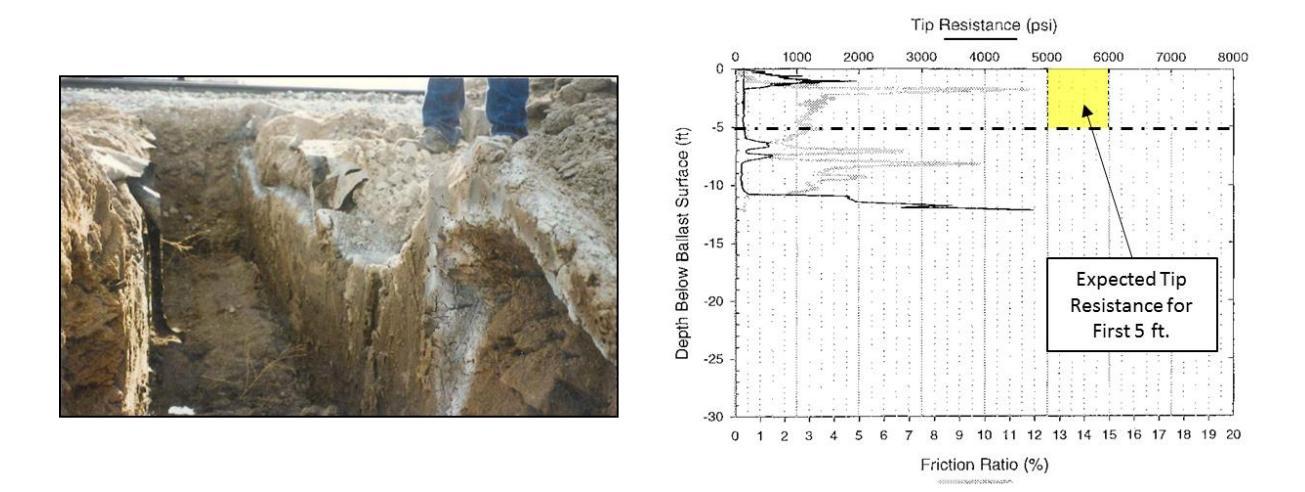
FIGURE 2: EXCAVATED CROSS-TRENCH (LEFT) AND CONE-PENETROMETER RESULTS (RIGHT)

Various measurements were collected on this site prior to its rebuild to support the approval of the maintenance activity. Soil investigation via cross-trench excavation and cone penetrometer testing conducted in 1996 on the central of three tracks indicated a particularly poor subgrade (Figure 2). The primary component of the subgrade was shown to be highly plastic clay. Cone-penetrometer testing indicated that this material in particular, and the overall substructure in general, was very weak. The top 5 ft. below the top of the ballast was exceptionally weak due to the fouling. Tip resistance was measured to

a maximum value of ~2000 PSI where the expected tip resistance at this depth is to be between 5000 to 6000 PSI.

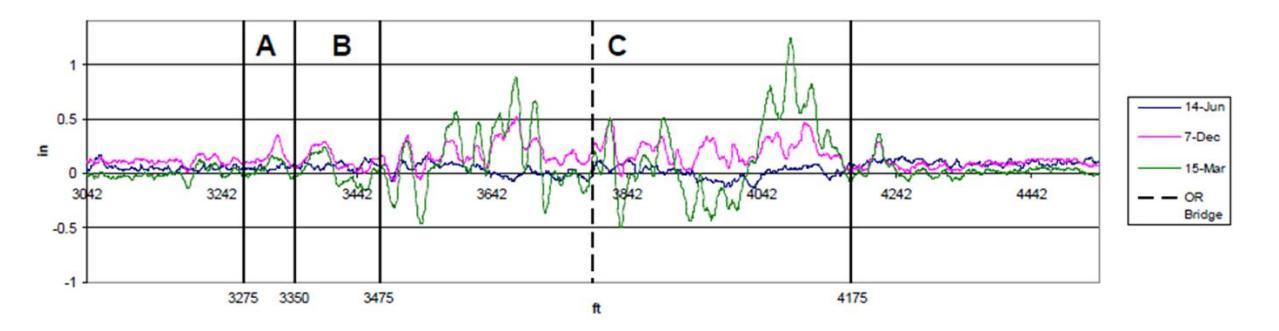
Track geometry measurements made before the rebuild also supported the existence of a subgrade issue. Figure 3 shows cross-level data compiled over an 8 month period before the rebuild. The central section C showed rapid degradation of not just the cross-level, but also other track geometry channels such as surface.

Using the available track condition information, section C from Figure 3 was chosen as the site for installation of the geocell material. This location was chosen because of its on-going maintenance issues as well as the availability of both a maintenance window and the geocell material¹. Two additional sections,

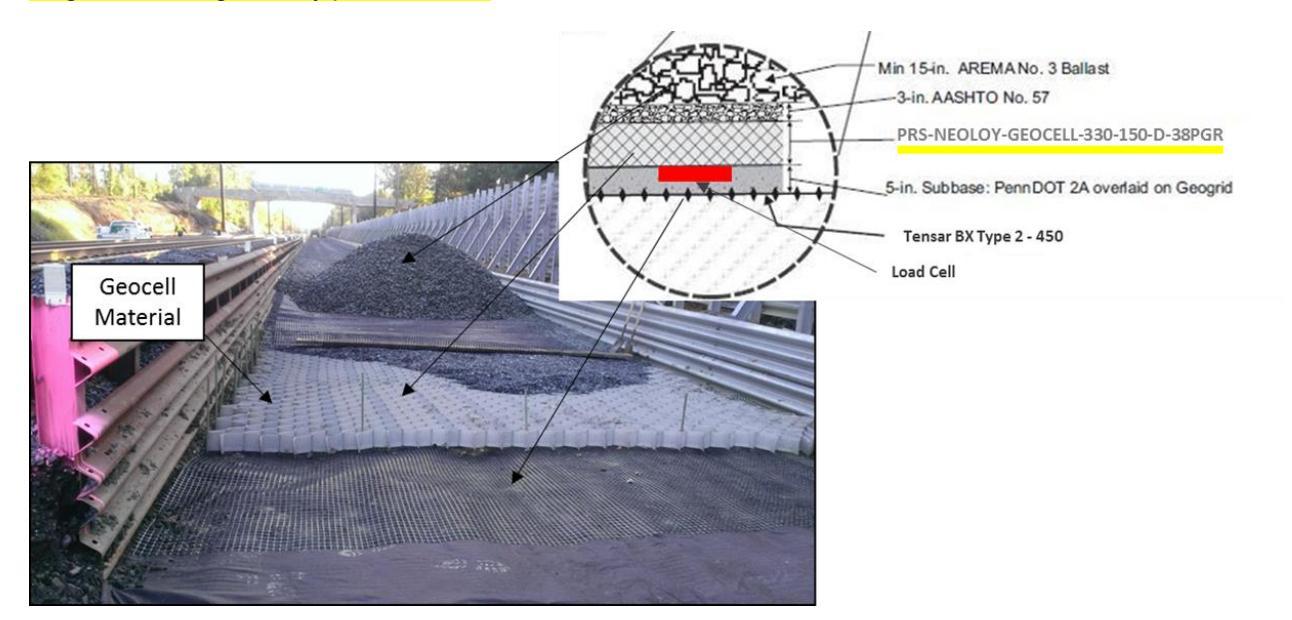
FIGURE 4: CROSS-SECTION OF THE SUBSTRUCTURE DURING REBUILD

During the rebuild, the track and substructure was removed down to the subballast. After re-compacting of the subballast and installation of additional drainage, the track was rebuilt. Figure 4 shows the various material layers utilized during rebuild process in the section of track with the geocell material. The NPA Geocell material utilized has high elastic stiffness (>600 MPa @60^oC), high resistance to creep (deformation <3%) and high tensile strength (>19 kN/m) properties, which are important for maintaining long-term track geometry performance.

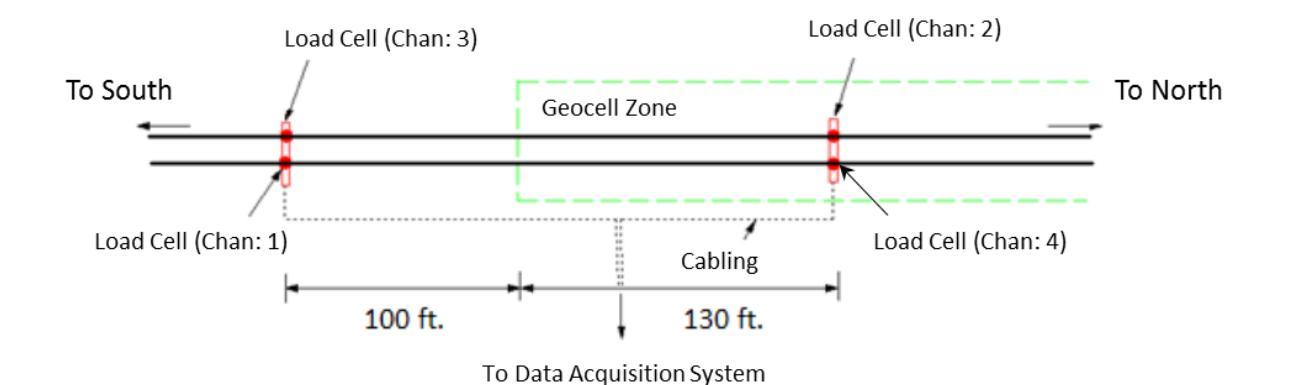
FIGURE 5: LOAD CELL POSITIONS AND CHANNEL ID NUMBERS IN TRACK

As part of the rebuild, pressure load cells were installed beneath each of the two rails (see Figure 5) at the top of the subbase layer (see Figure 6). The goal of this instrumentation was to study how the substructure dissipated the load of the passing train over time.

Figure 5 shows where the 4 load cells were positioned under the rebuilt track. In this configuration, 2 load cells were positioned within the geocell reinforcement zone (channels 2 and 4) and two were placed in the rebuilt track region which did not have a layer of geocell installed (channels 3 and 1); roughly 230 ft. apart. The load cells were placed at an equal depth below the rail at the top of the subgrade (Figure 6). In the geocell zone, this depth placed the load cell just under the geocell material.

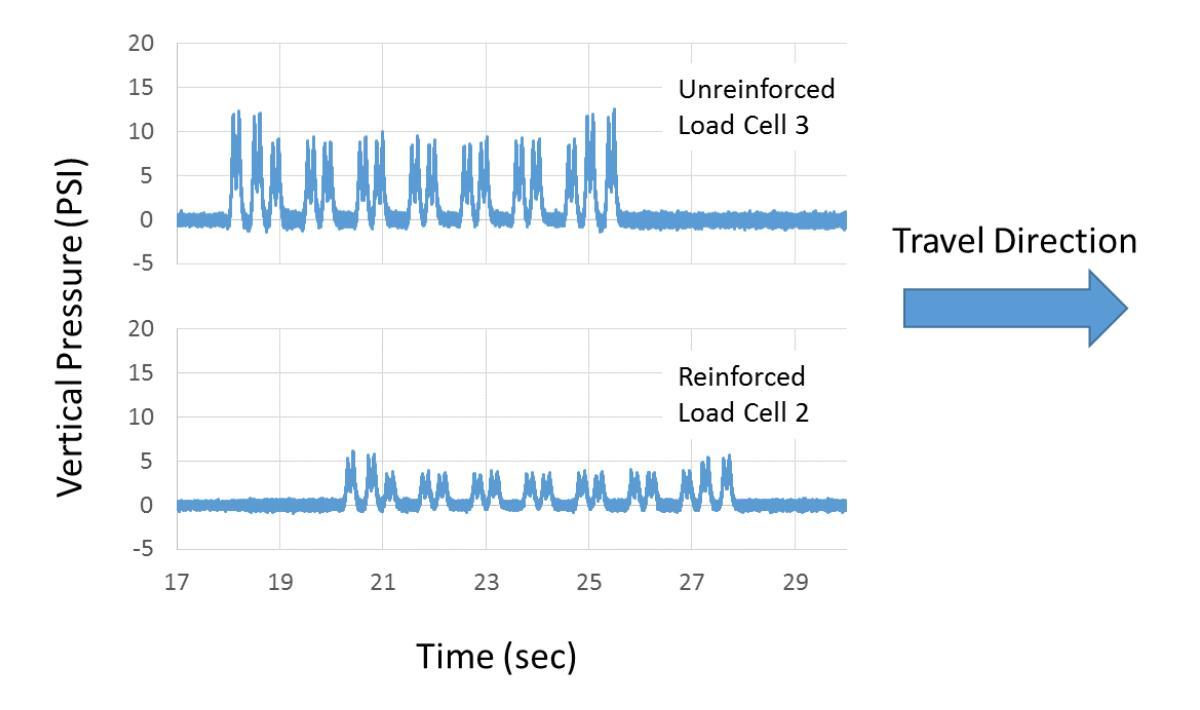
FIGURE 7: TYPICAL LOAD CELL RESPONSE OF PASSING HIGH SPEED TRAIN (WEST SIDE RAIL)

During any particular date, multiple train car pressure measurements were taken to generate a large distribution of data. Measurements were identified as either high speed or regional trains due the weight differences in both the passenger cars and the associated locomotives as well as the variation in train speeds. A typical pressure response of a passing high speed train is shown in Figure 7. Examination of this data shows that in the section of track which was reinforced with the geocell material, recorded pressure data magnitude was roughly half that of the pressures in the non-reinforced rebuilt section of track. This was typical of the pressure cell data recorded during this phase of the activity.

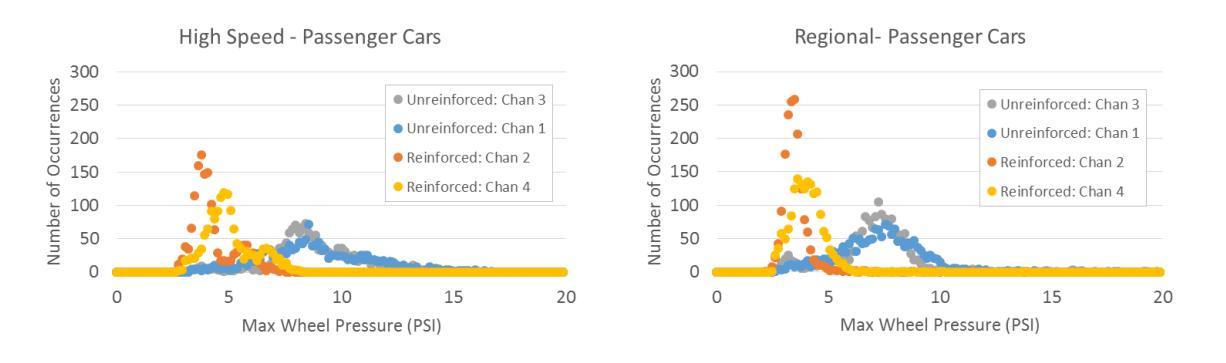
FIGURE 8: DISTRIBUTION OF MAX WHEEL PRESSURES (PASSENGER CARS)

At the conclusion of the data collection activity, the pressure data was compiled and analyzed to understand how the substructure was behaving and if the geocell material had an effect on performance from a pressure distribution standpoint. Figure 8 illustrates how maximum passenger car wheel response varied by location (load cell number) and train type/speed for the full entire dataset. As can be seen from Figure 8, the distribution of measurements show that the pressure readings for the track section reinforced by the geocell material are significantly lower than the non-geocell track sections. In addition, the distribution of the pressure readings (e.g. the standard deviation of the data) is more highly concentrated (has a lower deviation) for the geocell zone than for the non-geocell zones. Figure 9 shows how the substructure pressure varied over time. Again, it can be seen that for the zone with the geocell material, load cell measurements were consistently below that of the unreinforced (non-geocell) region of track.

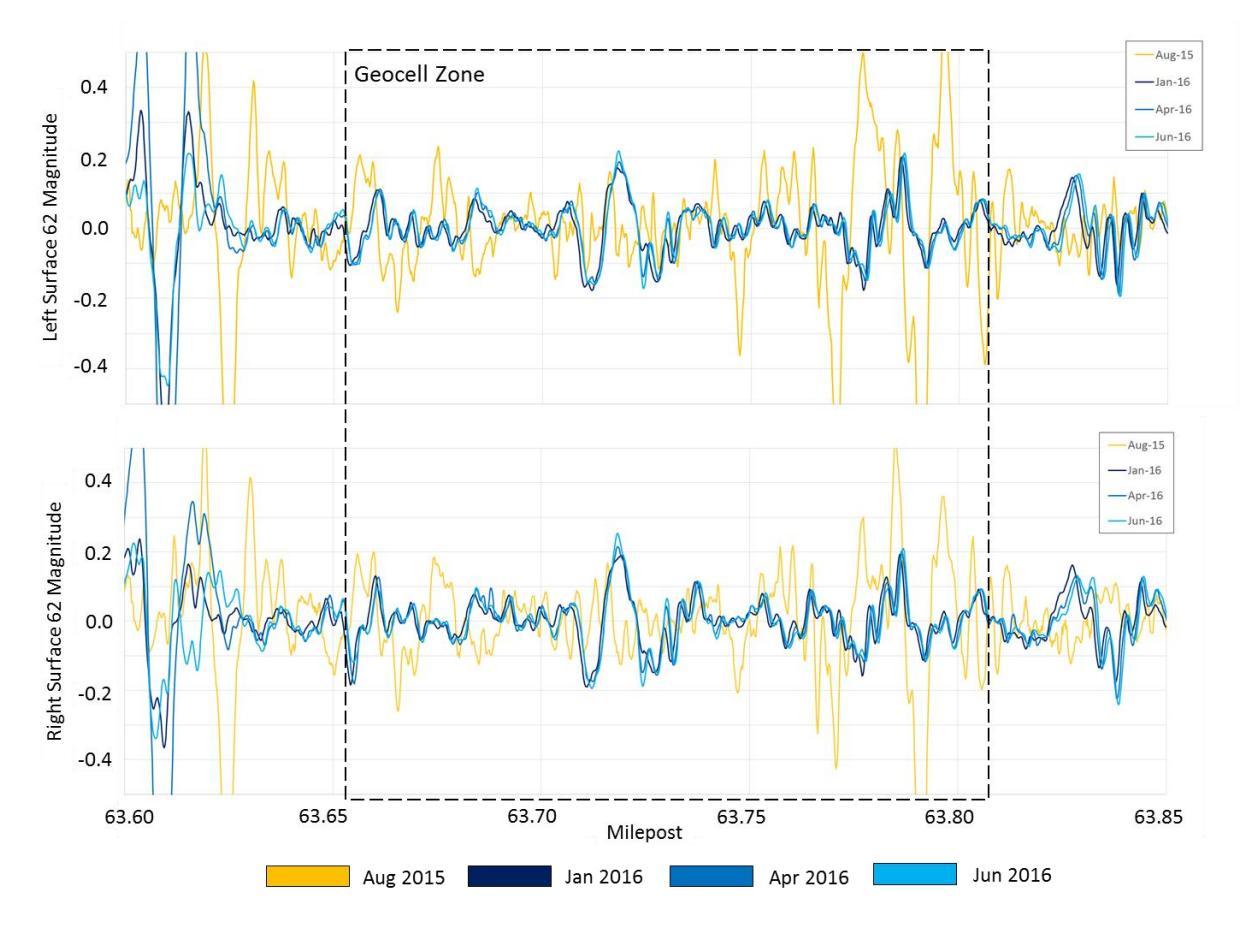
FIGURE 10: LEFT AND RIGHT SURFACE 62 PRE AND POST SEPT. 2015 REBUILD

Figure 10 shows surface 62⁶ data plotted for multiple dates across the rebuild region. The August 2015 data plots show how the rails were behaving before the rebuild which occurred late September 2015. Note that on the southern end of the geocell zone (~MP63.76 to 63.80), the surface data indicated that prior to rebuild there was significant degradation of the track geometry as illustrated by the large deviations from the mean. After rebuild and installation of the geocell material, which corresponds to the geometry data presented for January, April, and June of 2016 (a 6 month period after the rebuild), there was little track geometry degradation. A peak, relative to the surrounding area but still within an acceptable level of magnitude, was still present after the rebuild at roughly 63.725 indicating that a possible underlying issue was not dealt with.

Overall, these results suggest that the geocell layer "stabilized" track geometry degradation which only exhibited a modest amount of degradation post-rebuild. The same improvement was seen for other track geometry measurements made within the geocell zone. In contrast, in the rebuilt section outside the geocell zone in the vicinity of MP 63.60 to 63.64, the high rate of geometry degradation continued after the rebuild as illustrated in the January, April, and June of 2016 geometry data.

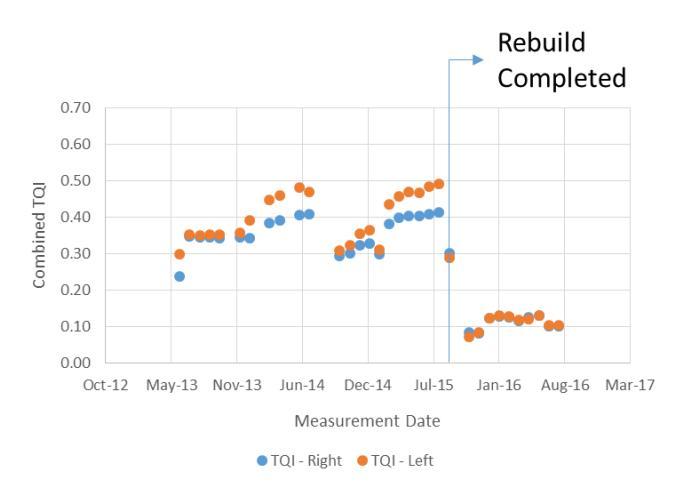
FIGURE 11: COMBINED TQI OVER TIME - REINFORCED ZONE (MP 63.76 TO 63.80)

Figure 11 and Figure 12 present the combined TQI analysis for both left and right rails from May 2013 through August 2016. Two regions of the rebuild site are presented, one with the geocell layer (reinforced / MP 63.76 to 63.80) and one without (non-reinforced / MP 63.60 to 63.64). For the segment with geocell material added (Figure 11) the TQI shows a significant reduction in the rate of degradation (slope of the TQI vs time curve) after installation of the geocell material in late September 2015. In addition, the low TQI value achieved after the rebuild was being maintained by the geocell material in the reinforced zone around MP 63.80. This was not the case with the non-reinforced segment (no geocell added during rebuild) which, as can be seen in Figure 12, shows that the high rate of geometry degradation observed before rebuild continued after the rebuild.

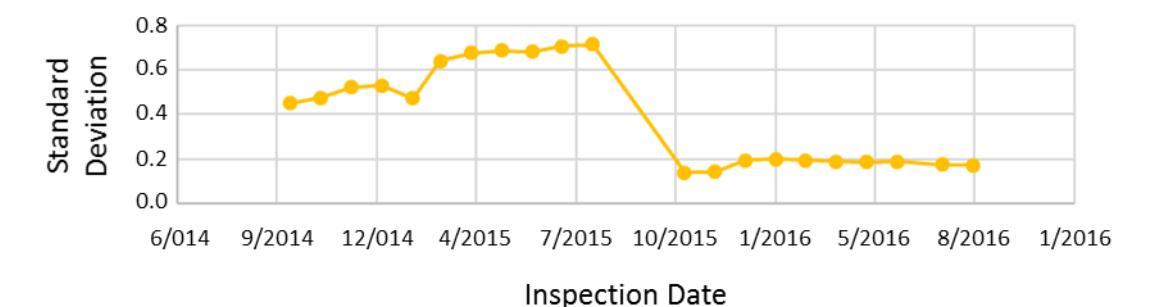
FIGURE 13: COMBINED TQI OVER TIME FOR THE SOUTHERN END OF GEOCELL ZONE

The rate of track geometry degradation, as measured in combined TQI, was then be calculated for the rebuilt geocell zone. The results from the southern end of the geocell installation zone (MP 63.76 to 63.80: Figure 13) were used to define the improvement in rate of track geometry degradation. Before the rebuild and geocell material installation, a TQI degradation rate of 0.0265 inches/month⁷ was calculated. After rebuild with the geocell material, a rate of 0.004 inches/month was calculated. This resulted in a reduction in the rate of track geometry degradation rate reduction on the order of 6.7.

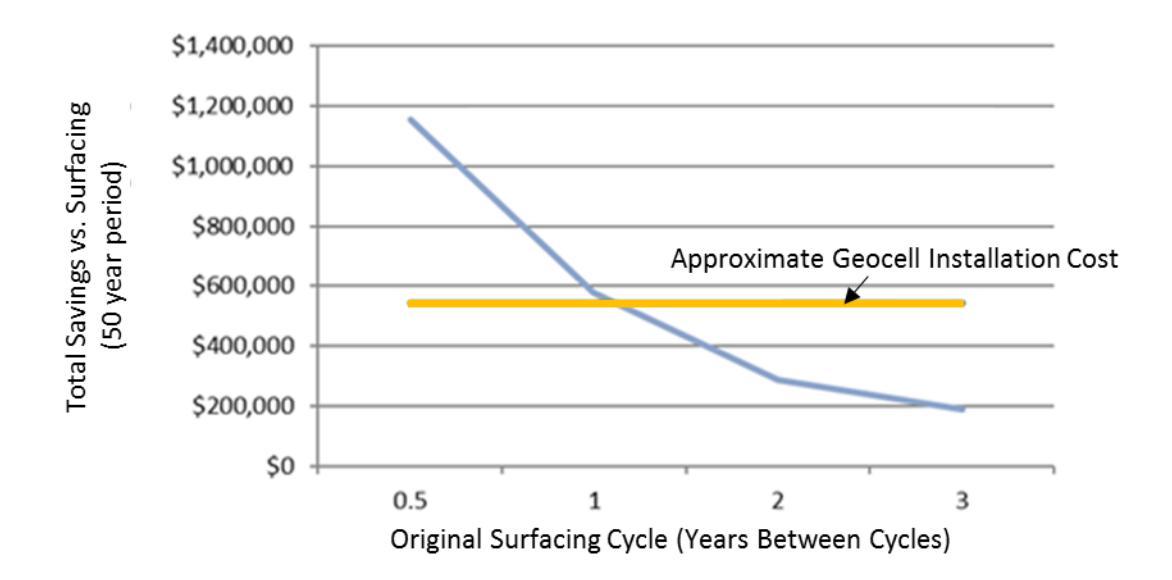
FIGURE 14: SENSITIVITY ANALYSIS: TOTAL SAVINGS VS. SURFACING

A sensitivity analysis was performed assuming a range of historical surfacing cycles, and assuming an improvement factor of 6.7. Figure 14 shows the results of this analysis and results are displayed as total savings over the assumed geocell life cycle (50 years). When the identified savings is greater than the current installation cost (shown as a yellow line on Figure 14) there is a positive benefit and associated return on investment (ROI). It can therefore be seen that there are clear benefits if the surfacing cycle is one year or less. Note that this analysis only considers the geocell installation cost compared to the savings associated with extension in surfacing cycle. It is assumed that additional life cycle savings can be achieved (not quantified as part of this study) associated with reduced track component and vehicle damage, delay costs due to track occupancy, and increased safety. For track locations where the current surfacing cycle is between 1 and 2 years, it will be prudent to identify these additional savings.

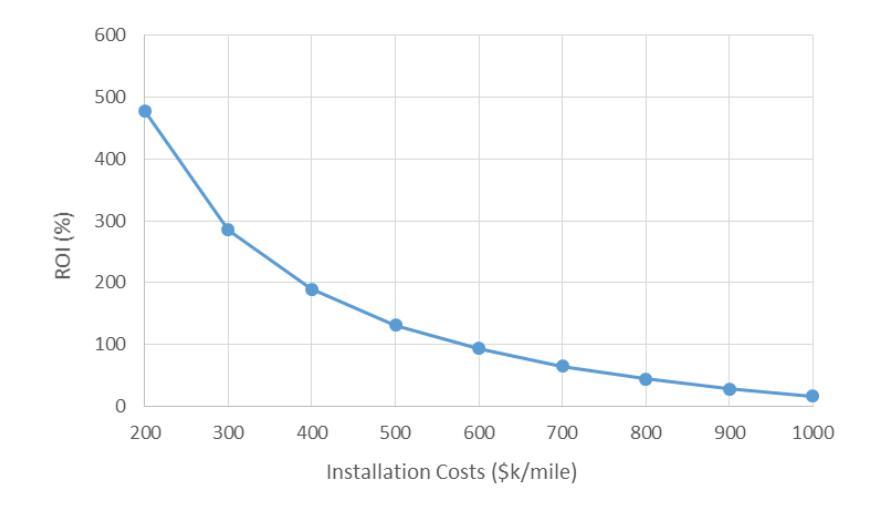
FIGURE 15: SENSITIVITY ANALYSIS: ROI VS. INSTALLATION COSTS

Figure 15 illustrates how ROI can vary based on the installation cost of the geocell material on a per mile basis while again holding the surfacing cycle extension constant at 6.7. For this study, the cost per mile was ~\$550,000/mile which corresponds to a ROI of 112%.
